CORE-LOC BREAKWATER ARMOUR RESEARCH

Breakwater Survey at Port St Francis

FINAL REPORT

Council for Scientific and Industrial Research (CSIR)

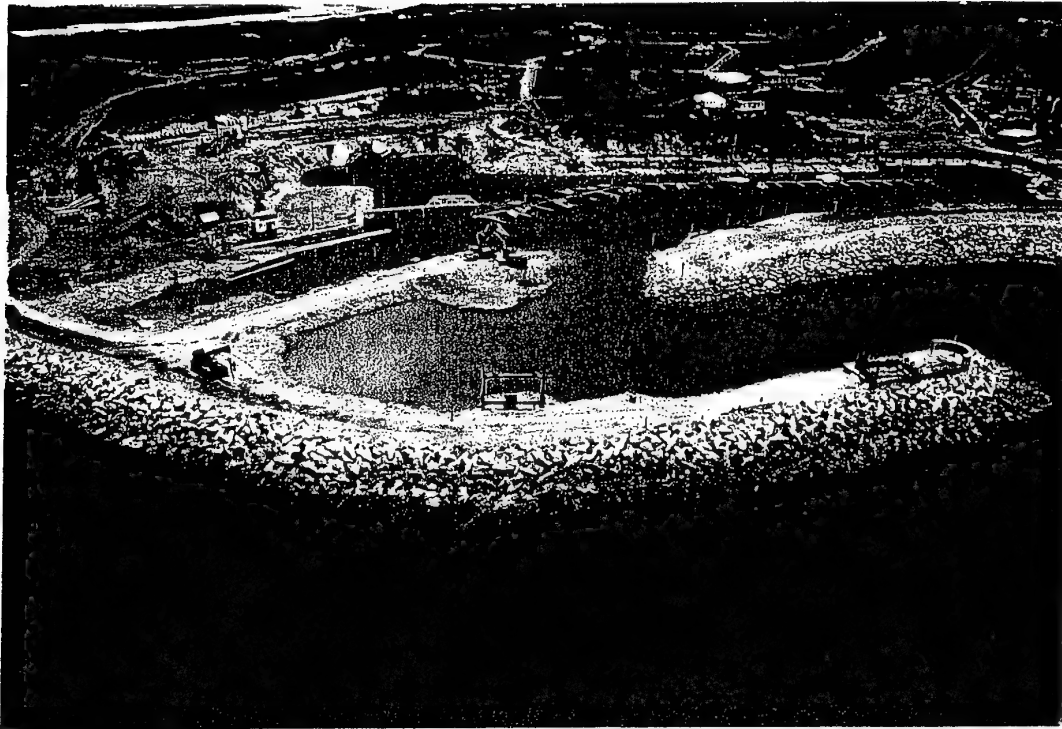
During the construction phase the low crest working level (+3,5 m MSL) left the breakwater unprotected against wave overtopping, resulting in the displacement of a number of crest units during the near design storms that were experienced before construction of the mass-capping. During one of the storms, overtopping caused a breach of the core material and the displacement of Core-loc units into the harbour. Most of these units were recovered and re-packed on the front slope. Some grading problems with the under-layer rock also caused an irregular profile. Figure 2 shows the breakwater, revetment and marina still under construction.

Breakwater revetment and marina under construction

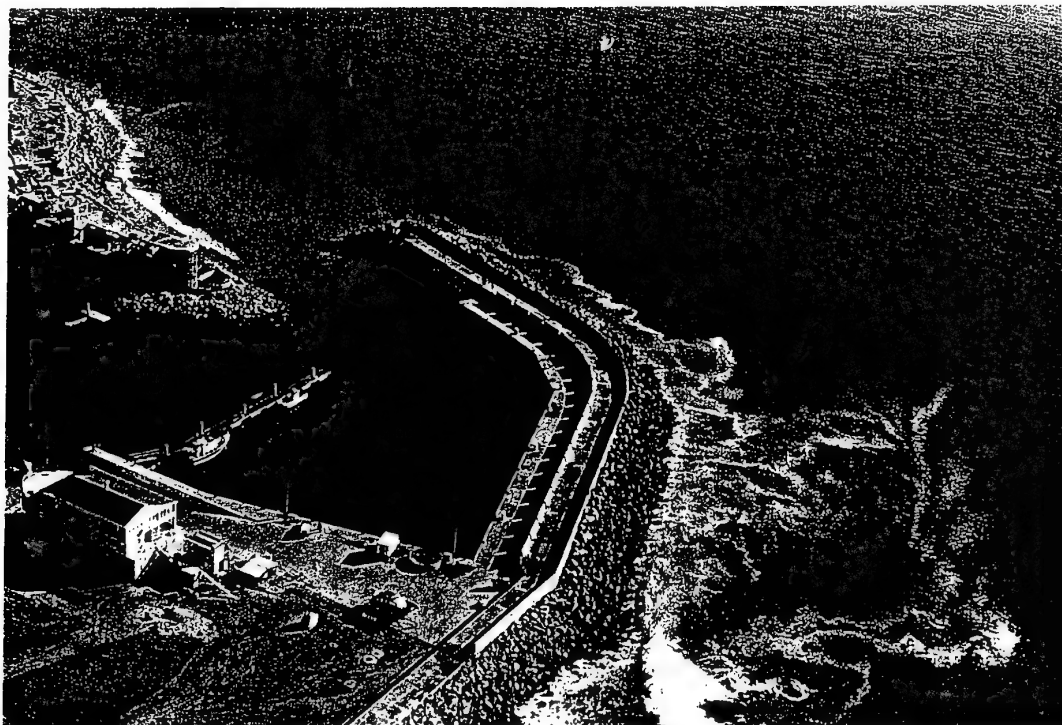
View of completed breakwater and revetment

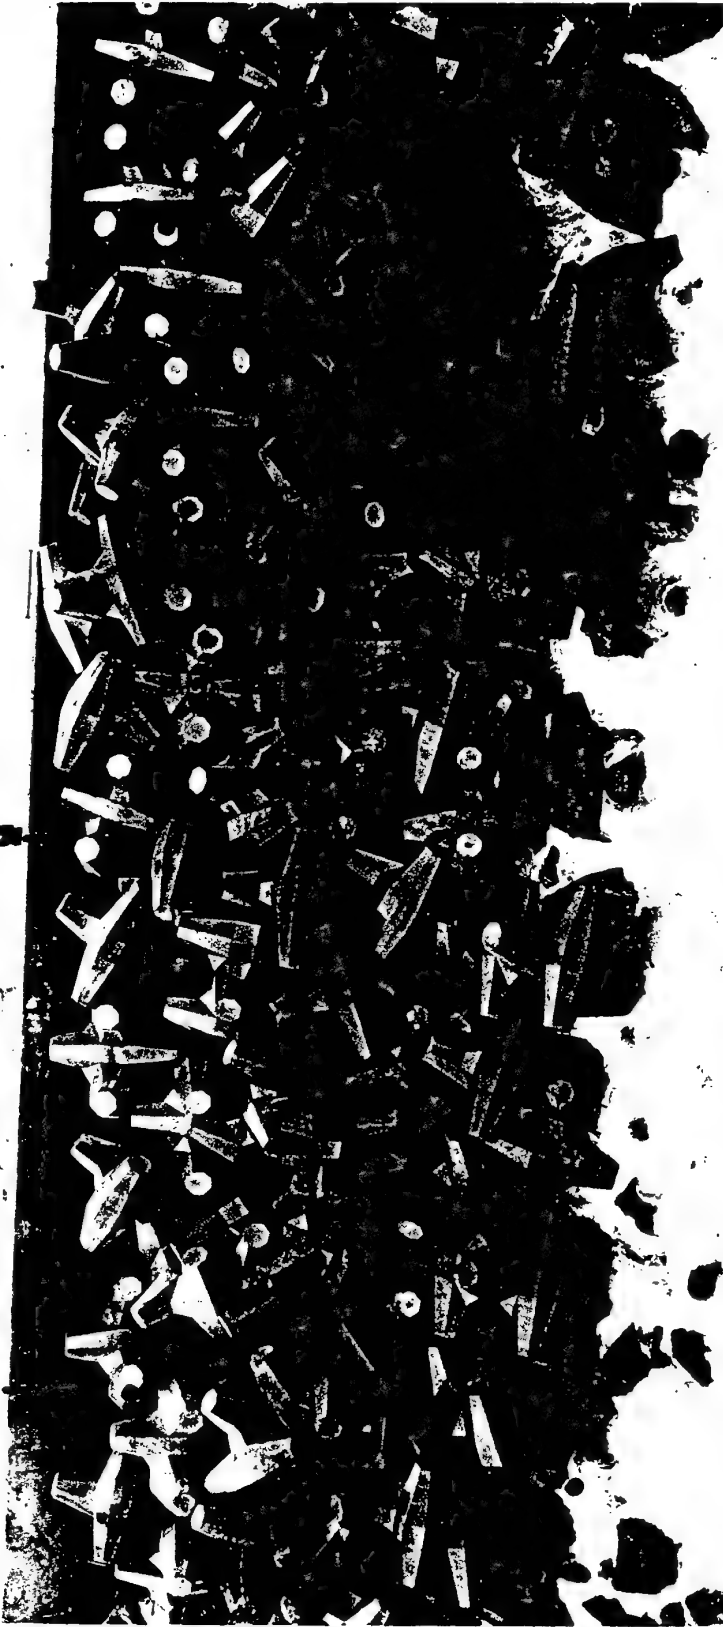
13

Move (■) : 0 Broken (▲) : 0 Lost (●) : 0
 N = New, P = Pieces, A = <0,5m, B = 0,5m to 1,5m, C = >1,5m

BASELINE PHOTOGRAPHIC SURVEY OCTOBER 1997
 STATION 3

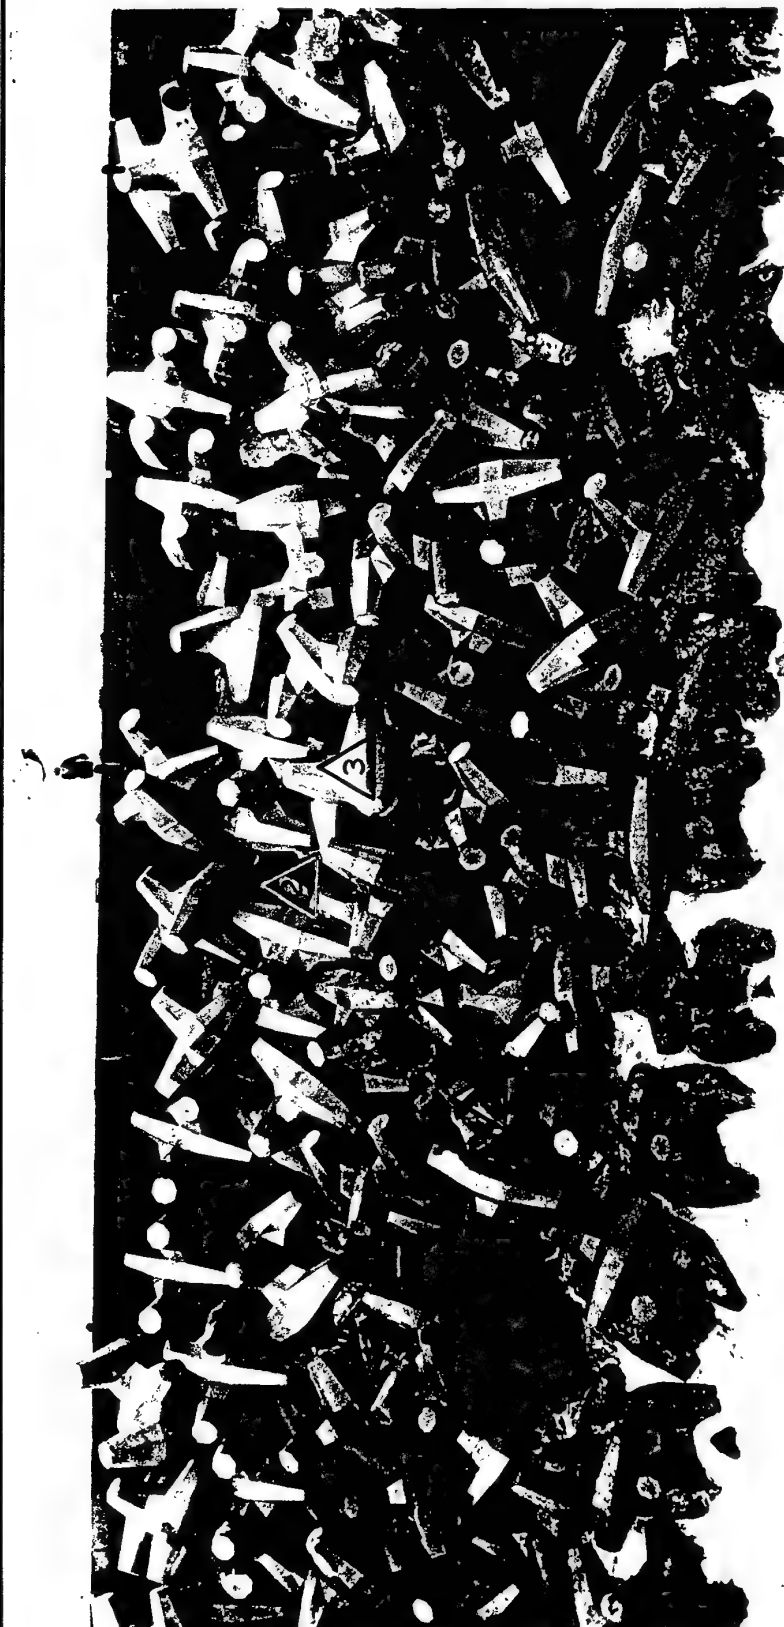
FIGURE
14

Move (■) : 0 Broken (▲) : 3 Lost (●) : 0
N = New, P = Pieces, A = <0,5m, B = 0,5m to 1,5m, C = >1,5m

BASELINE PHOTOGRAPHIC SURVEY OCTOBER 1997
STATION 4

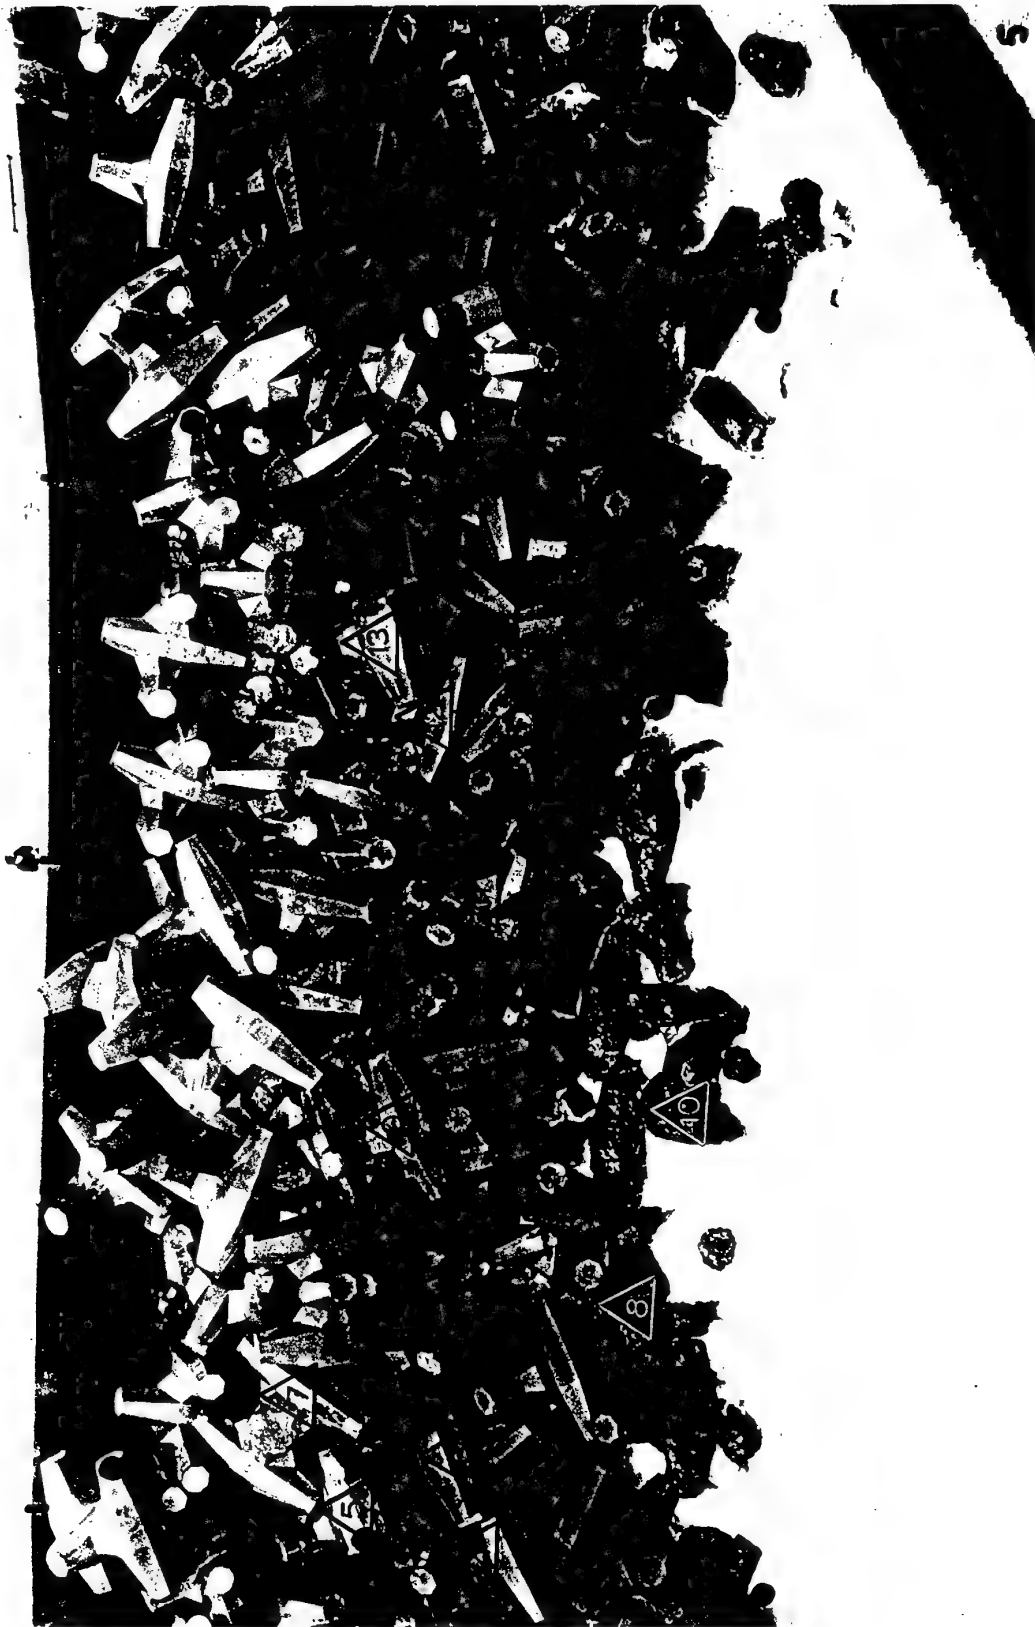
**FIGURE
 15**

Move (■) : 0 Broken (▲) : 10 Lost (●) : 0
 N = New, P = Pieces, A = <0,5m, B = 0,5m to 1,5m, C = >1,5m

**BASELINE PHOTOGRAPHIC SURVEY OCTOBER 1997
 STATION 5**

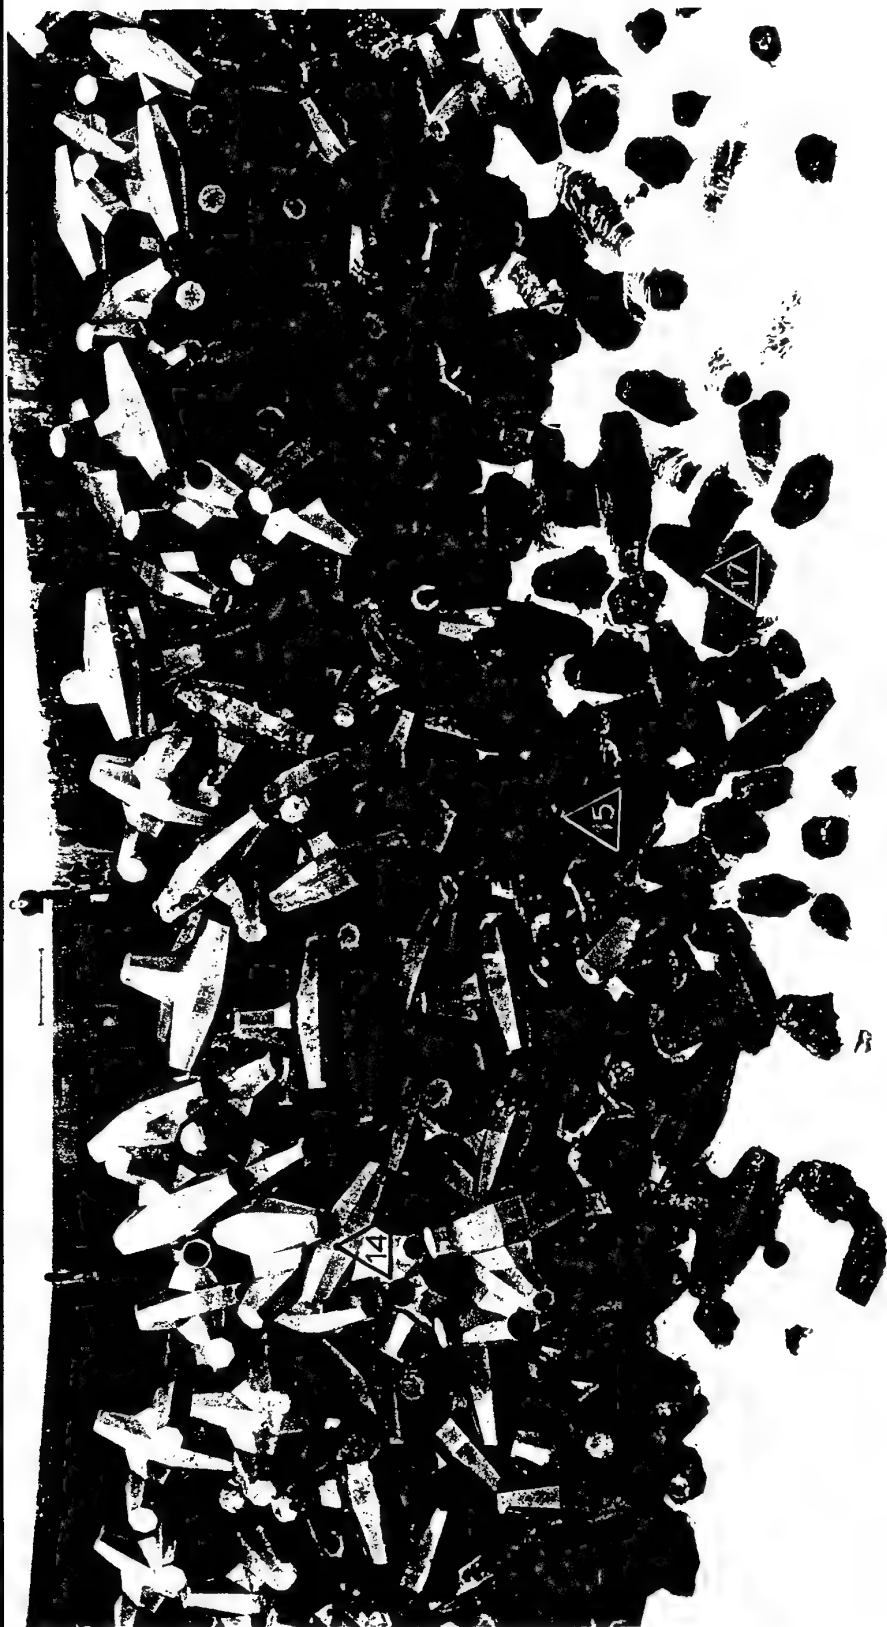
**FIGURE
 16**

Move (■) : 0 Broken (▲) : 4 Lost (●) : 0
 N = New, P = Pieces, A = <0,5m, B = 0,5m to 1,5m, C = >1,5m

**BASELINE PHOTOGRAPHIC SURVEY OCTOBER 1997
 STATION 6**

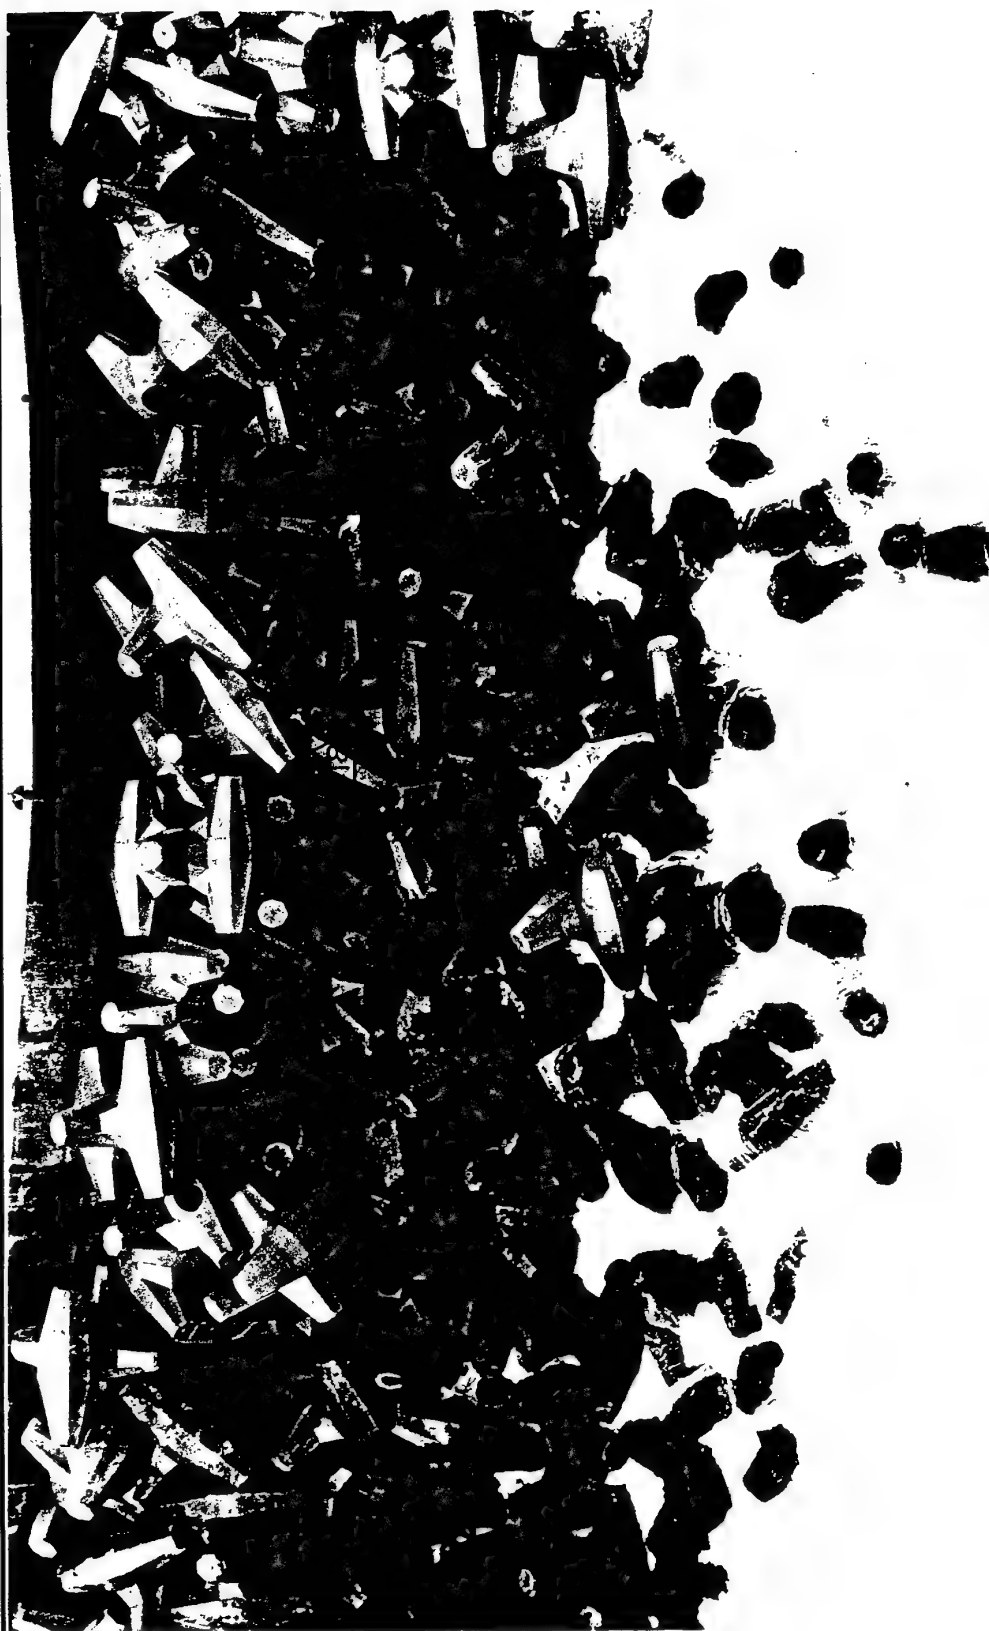
17

Move (■) : 0 Broken (▲) : 1 Lost (●) : 0
N = New, P = Pieces, A = <0,5m, B = 0,5m to 1,5m, C = >1,5m

BASELINE PHOTOGRAPHIC SURVEY OCTOBER 1997
STATION 7

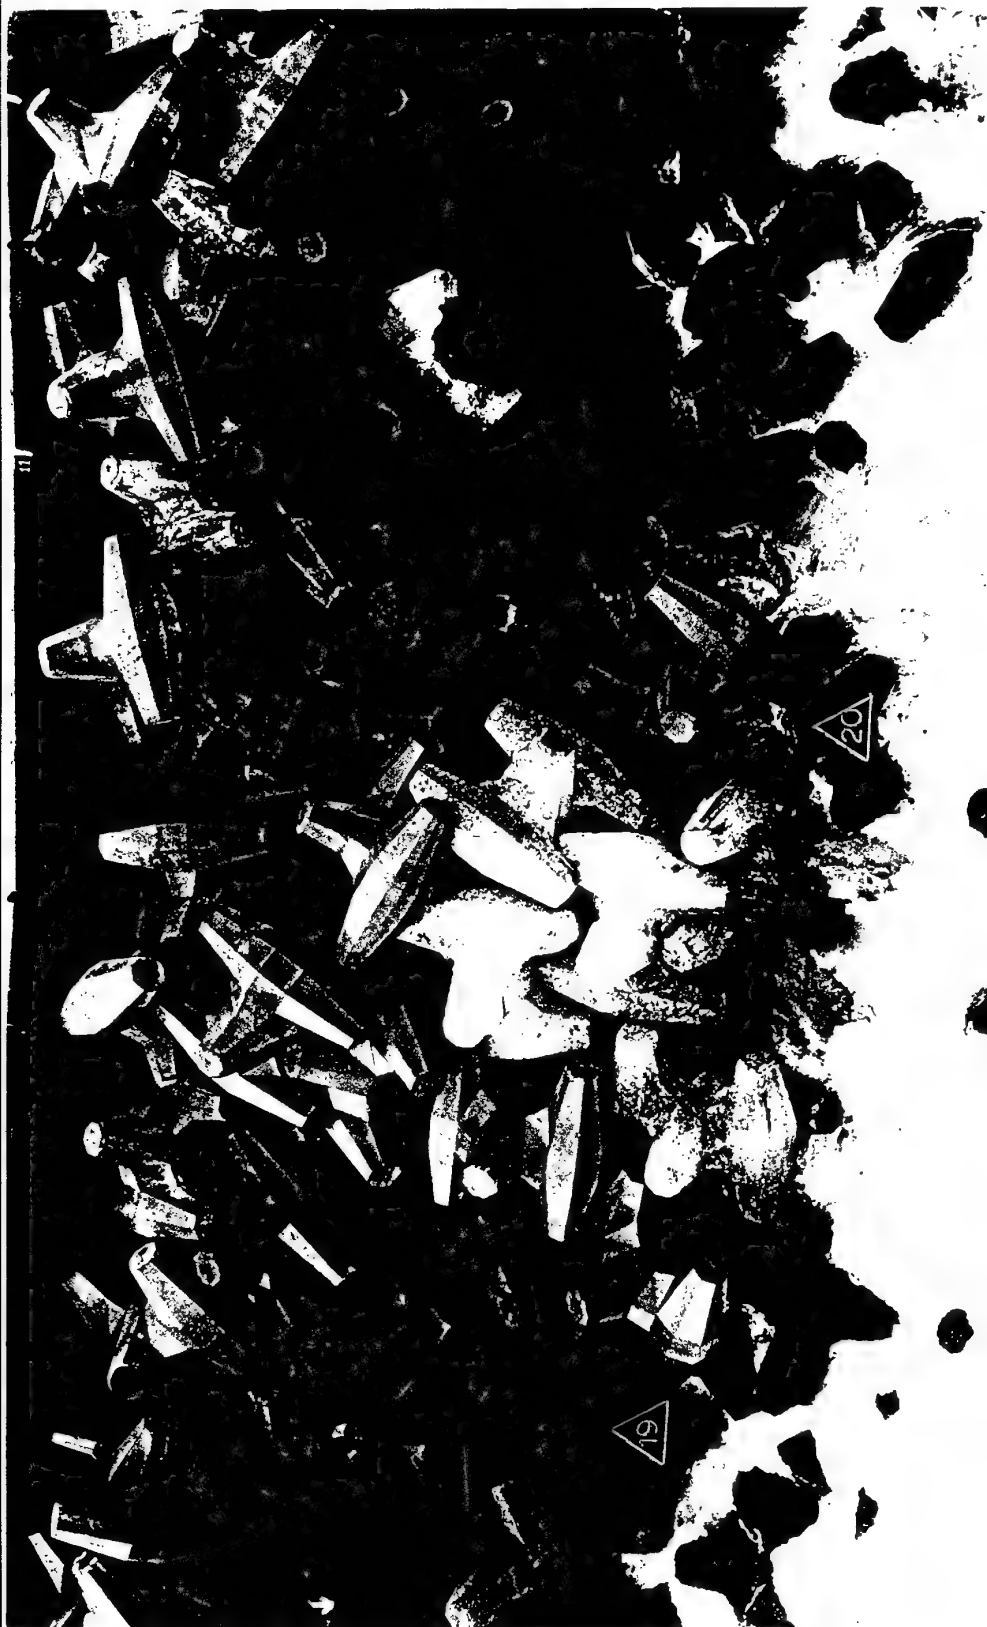
18

Move (■) : 0 Broken (▲) : 3 Lost (●) : 0

BASELINE PHOTOGRAPHIC SURVEY OCTOBER 1997
STATION 8

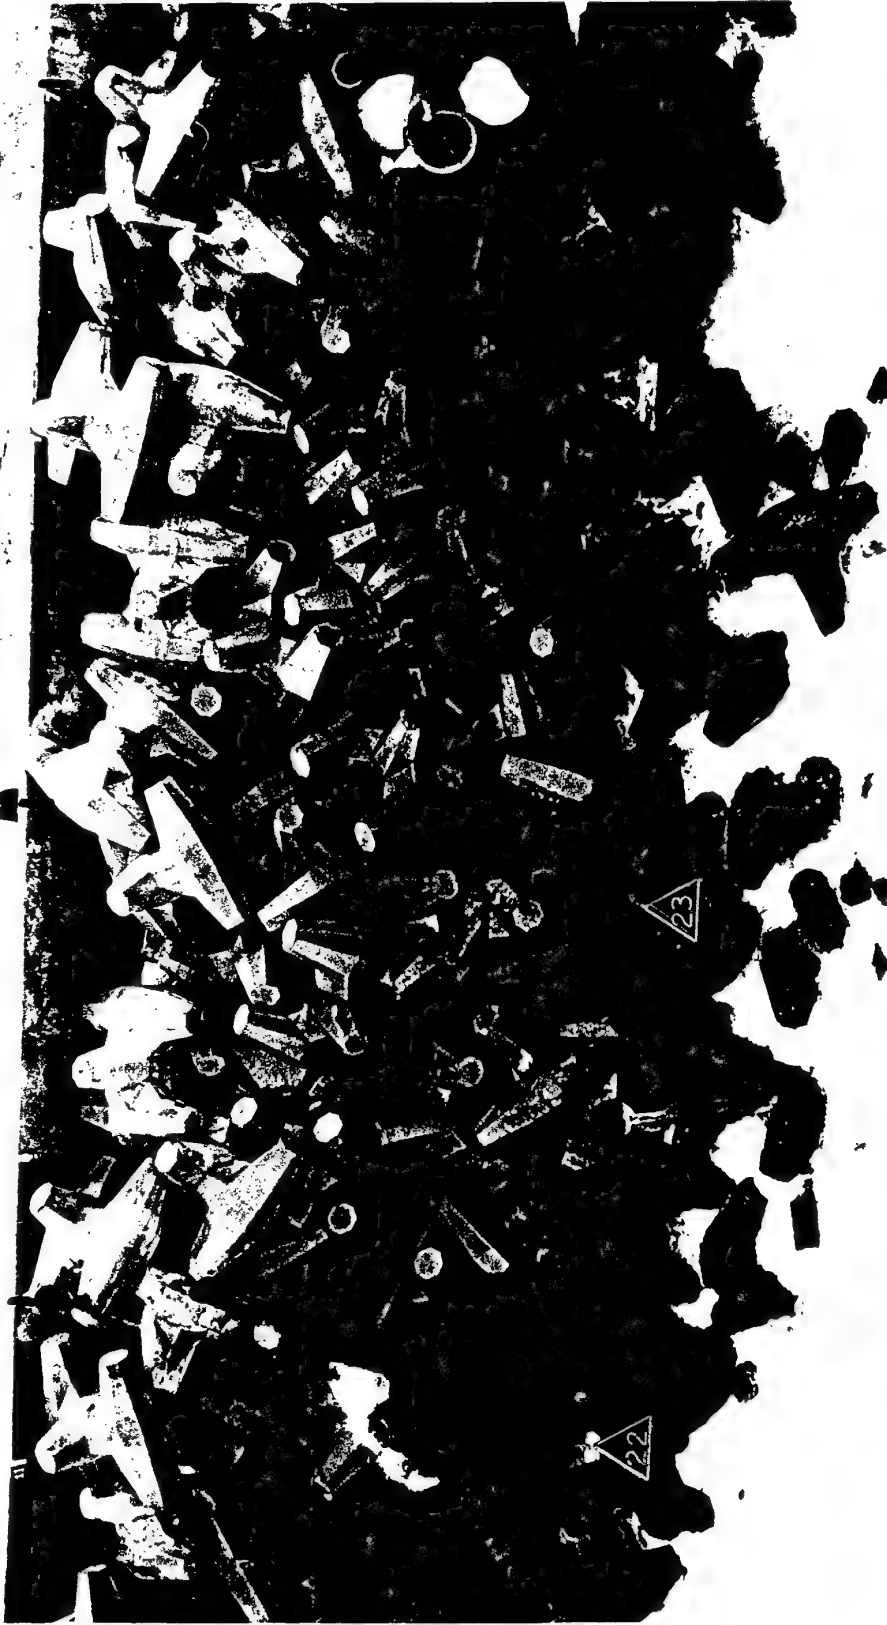
19

Move (■) : 0 Broken (▲) : 2 Lost (●) : 0

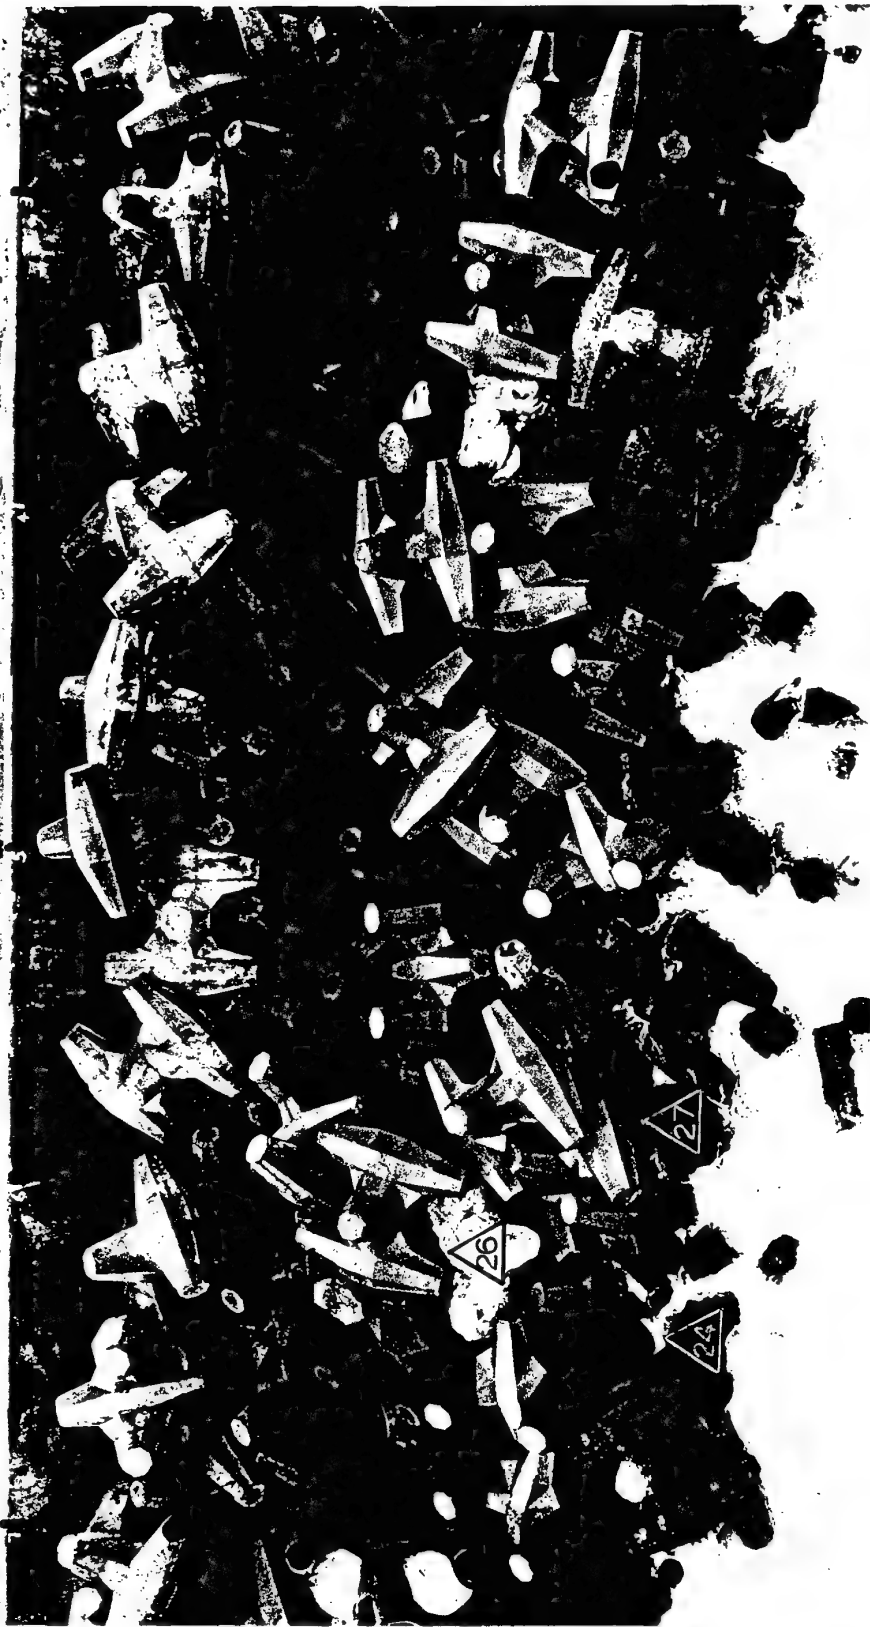
20

Move (■) : 0 Broken (▲) : 6 Lost (●) : 0
